Docket No. 217 – Development and Management Plan Inspection

Northeast Utilities Service Company Certificate of Environmental Compatibility and Public Need for the construction of a 345-kV electric transmission line and reconstruction of an existing 115-kV electric transmission line between Connecticut Light and Power Company's Plumtree Substation in Bethel, through the towns of Redding, Weston, and Wilton, and to the Norwalk Substation in Norwalk, Connecticut.

Date: June 15, 2005

Location: Norwalk Substation Expansion

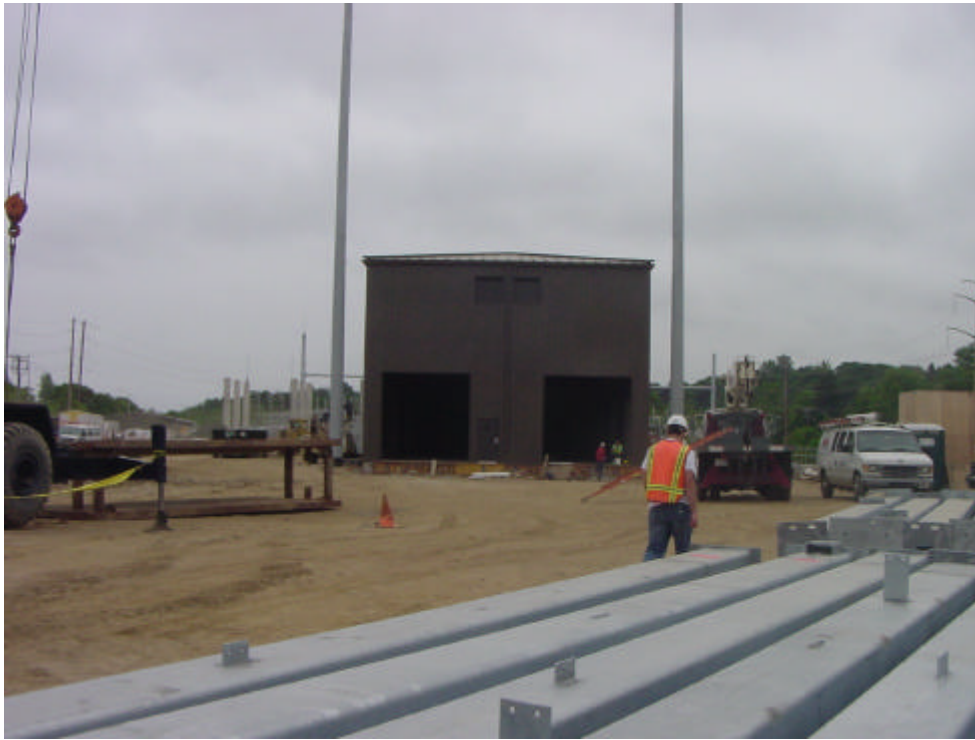
Norwalk Substation: View of the GIS Building from the back. (6/15/05)

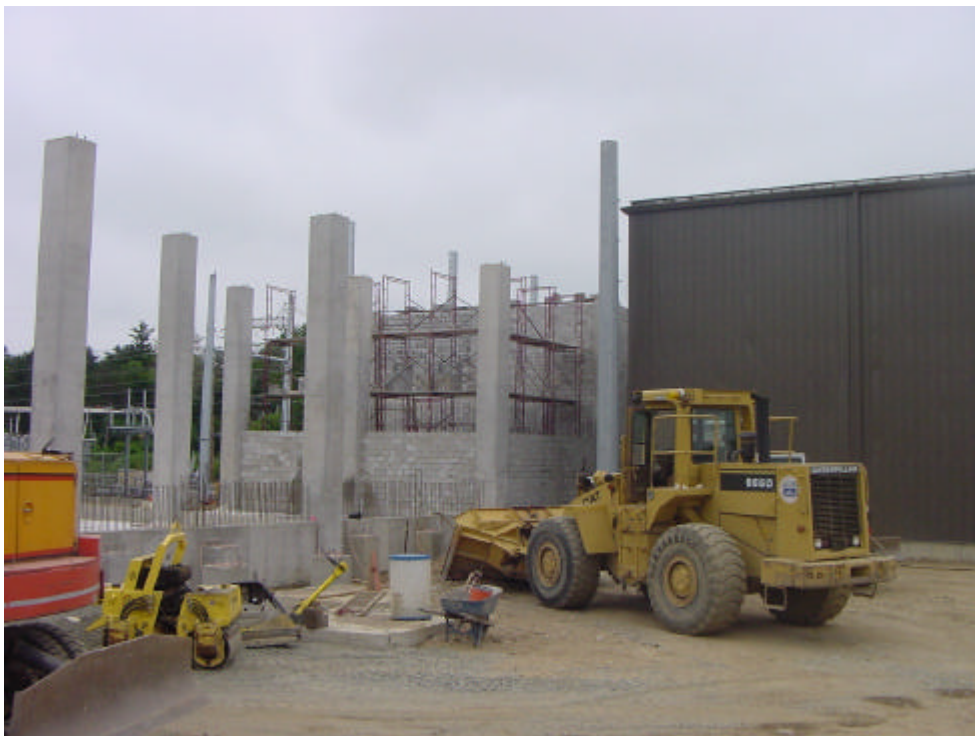
Concrete work being done between the control house and GIS Building. (6/15/05)

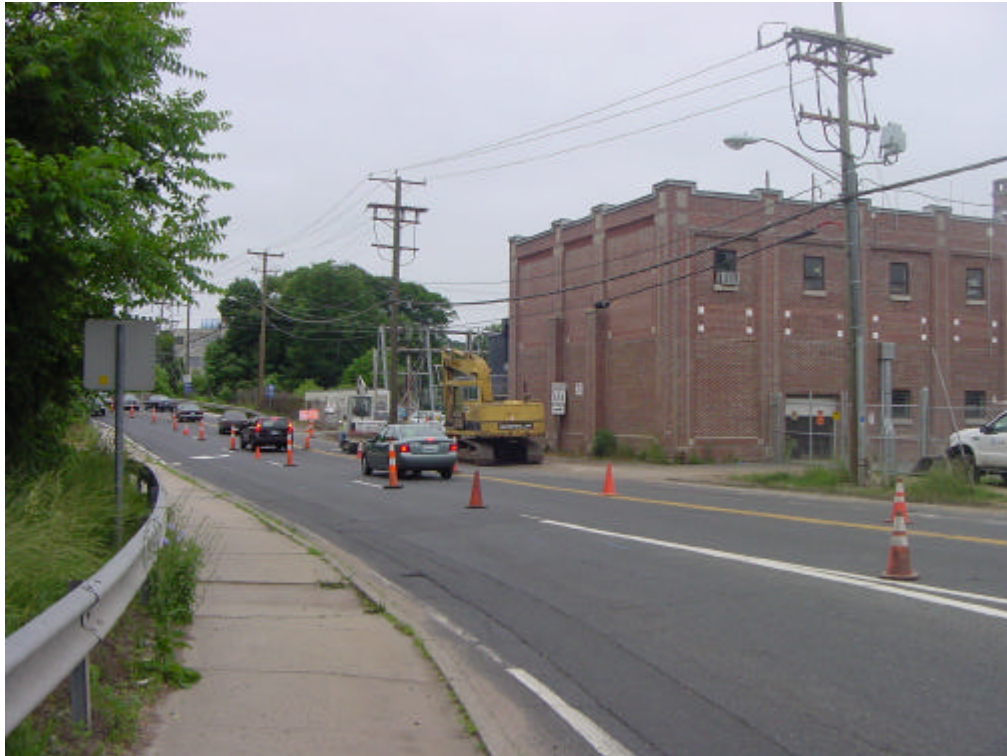
Concrete sidewalk being installed along New Canaan Avenue (RT 123). (6/15/05)

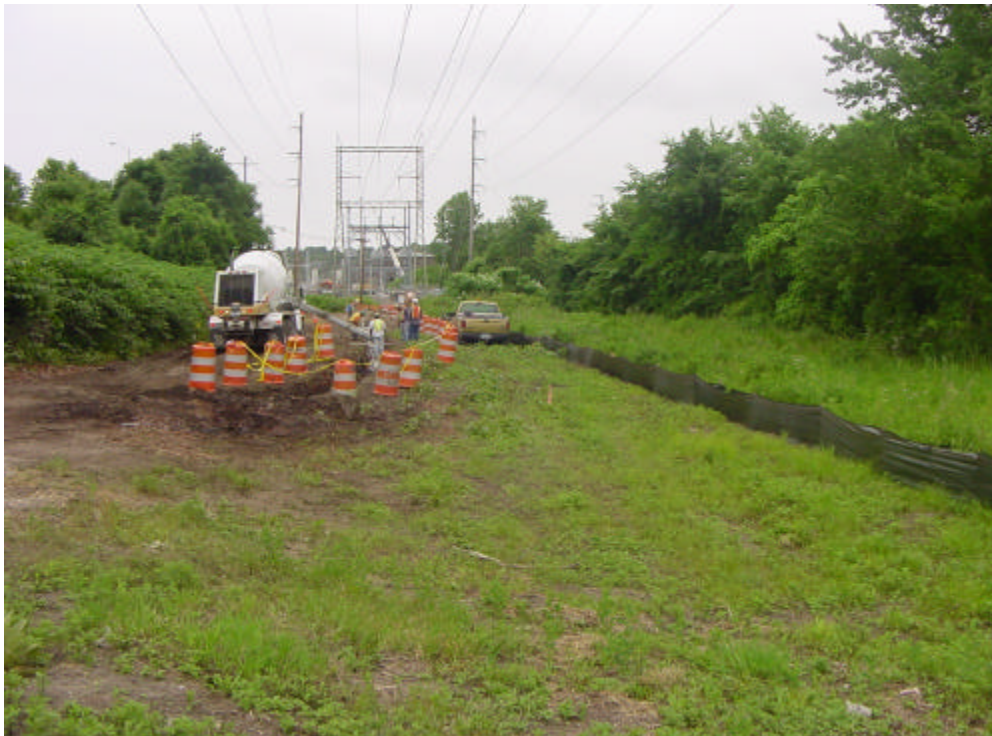
Pouring concrete over in conduit trench between Norwalk Substation and Broad Street as part of the 115kV project. (6/15/05)

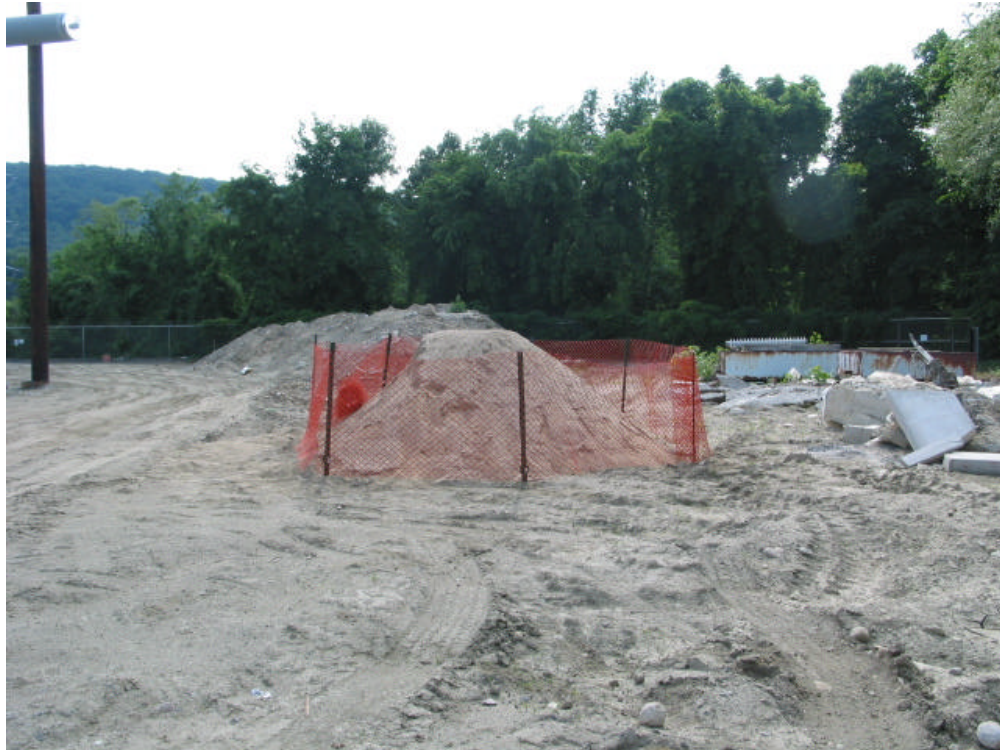
Plumtree Substation-View of the sand pile with the potential wood turtle nest. It has been encircled in safety/snow fence to prevent accidental disturbance. (6/15/05)

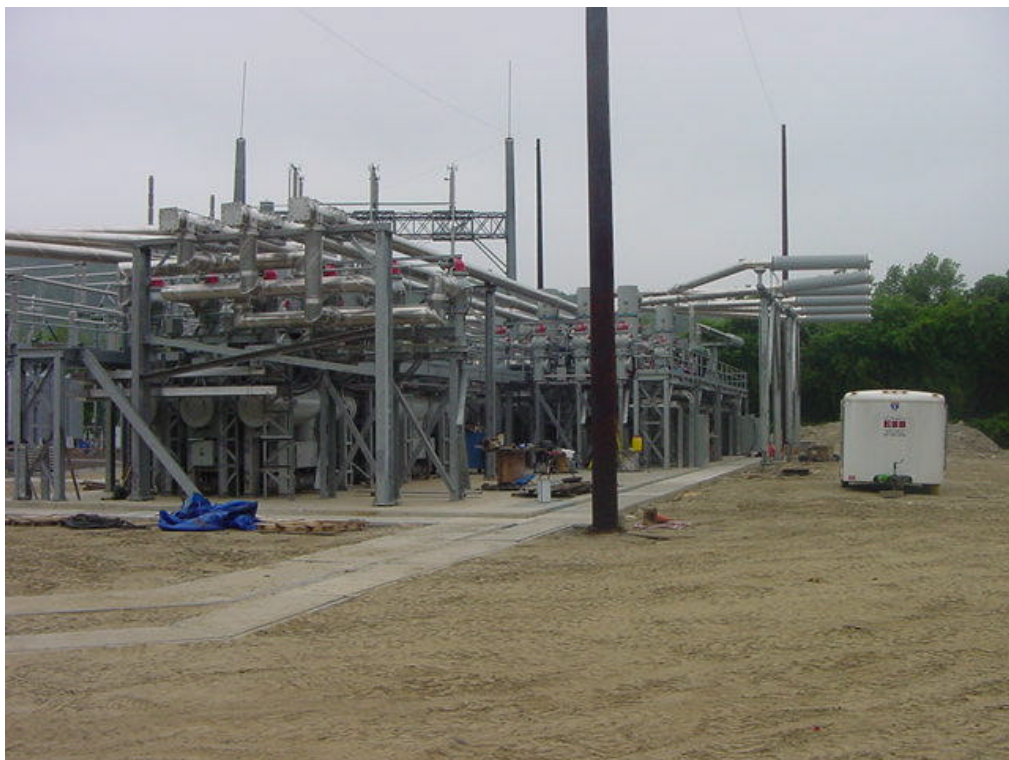
All the work is internal to the slab at this time. Trenches have been closed and there is a general clean up on site. (6/15/05)
